RE: WARNING LETTER OF POSSIBLE VIOLATIONS AND NON-COMPLIANCE

**Miami Harbor Phase III Federal Channel Expansion
Permit No. 0305721-001-BI
County: Miami-Dade**

**Field notes on impact assessment in Miami Harbor Phase III Federal Channel
Expansion Permit # 0305721-001-BI**

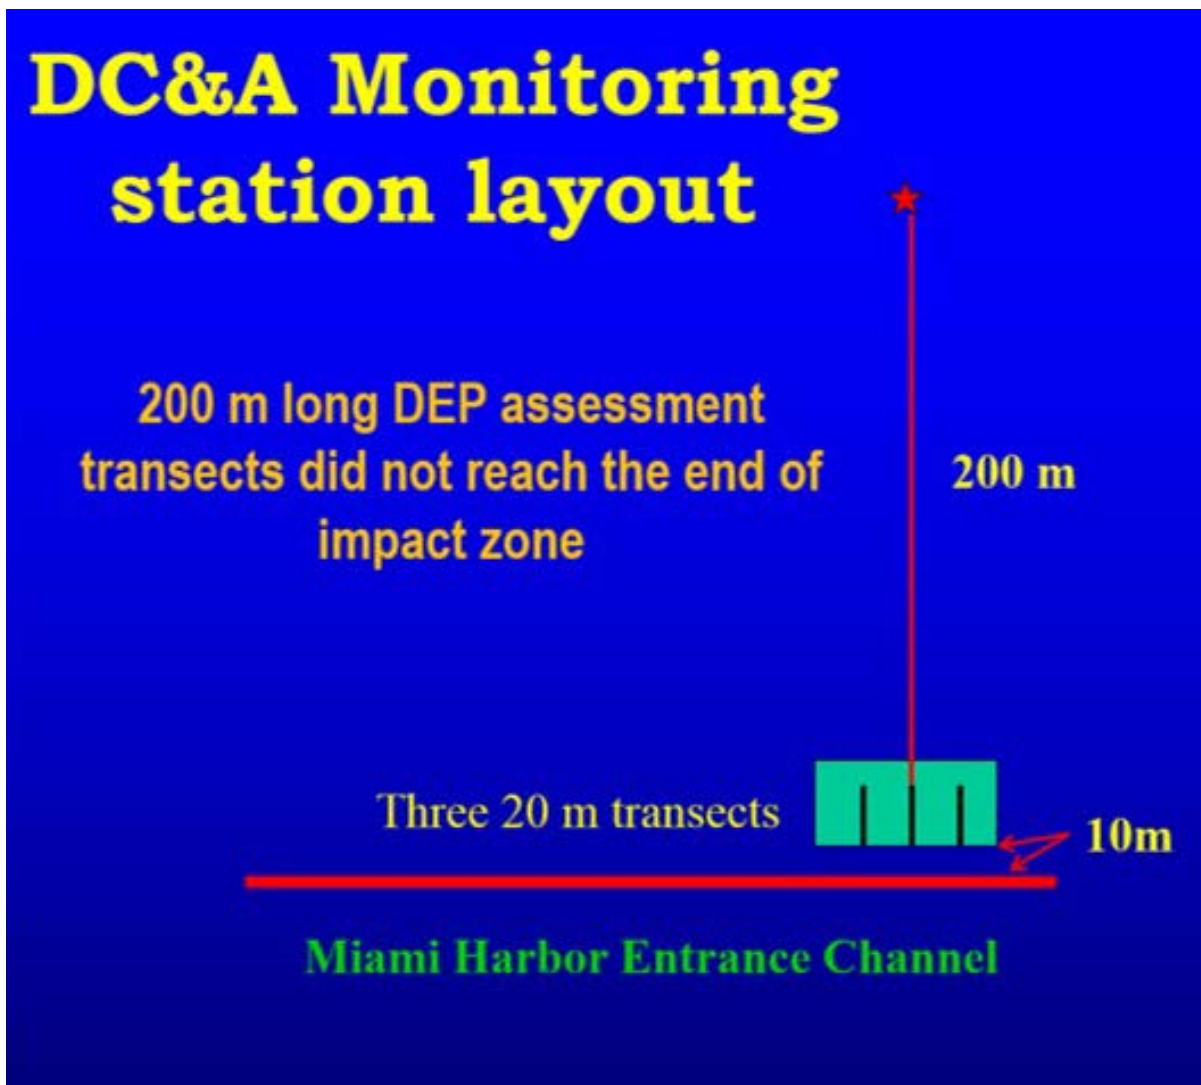
Figure 2. Monitoring station layout. DEP 200 m assessment transects initiated from one of 20 m monitoring transects.

The monitoring protocol for the Miami Harbor project was not designed to document possible impacts beyond the monitoring stations, which are located adjacent to the channel (10 m off the channel) and extended 20 m (Figure 2). However, according DEP Permit No. 0305721-001-BI, Specific Condition 32.a.ii.d, provides that “stress expressed

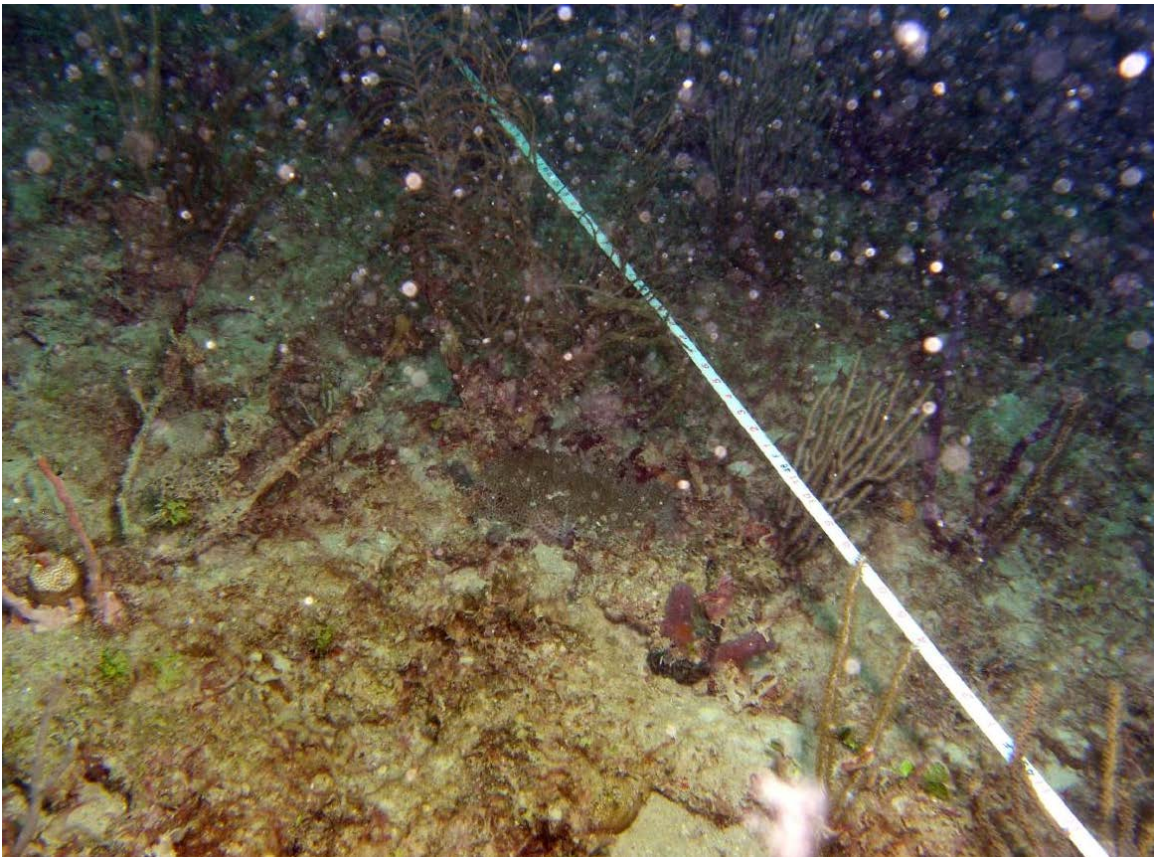
Figure 3. Landscape in Control Site HBSC1-CP. Low sediment cover, mostly accumulated in small pits. However, some cover of fine sediments exists; development of cyanobacterial mats seems to be related to this slight fine sediment cover.

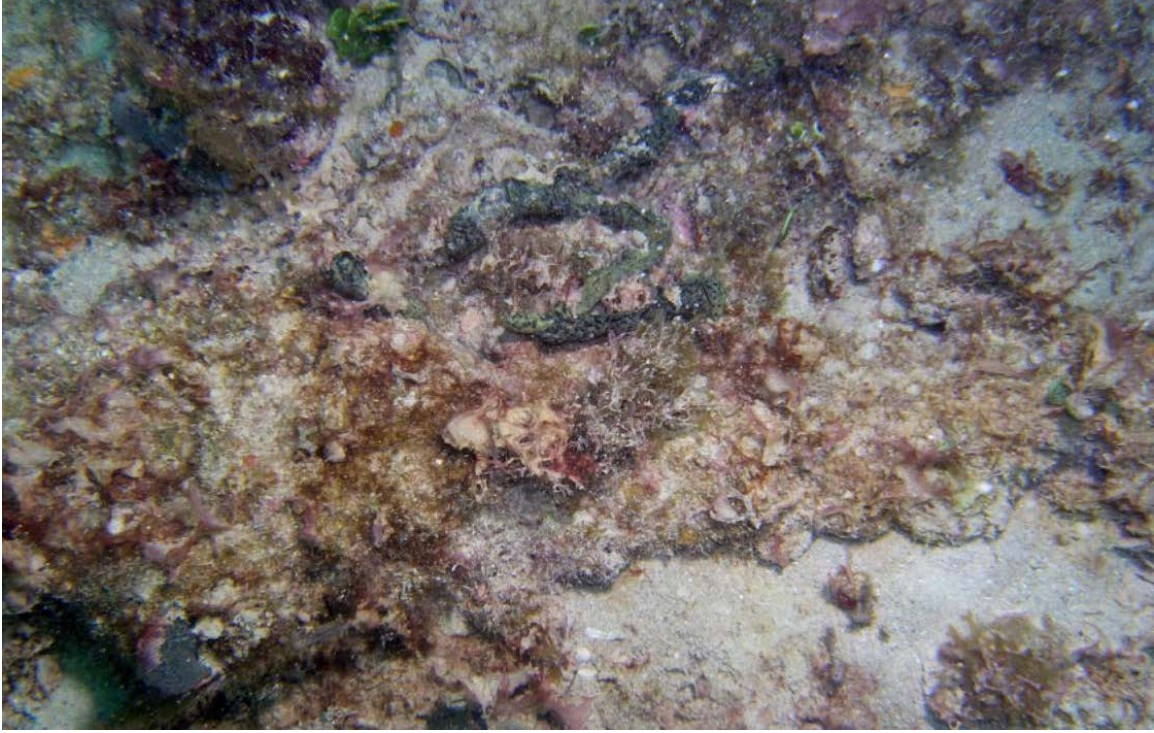
Figure 4. Cyanobacterial growth over hardbottom at Control Site HBSC1 seems to be related to light sedimentation of fine material accumulated rather on benthos than on sand patches.

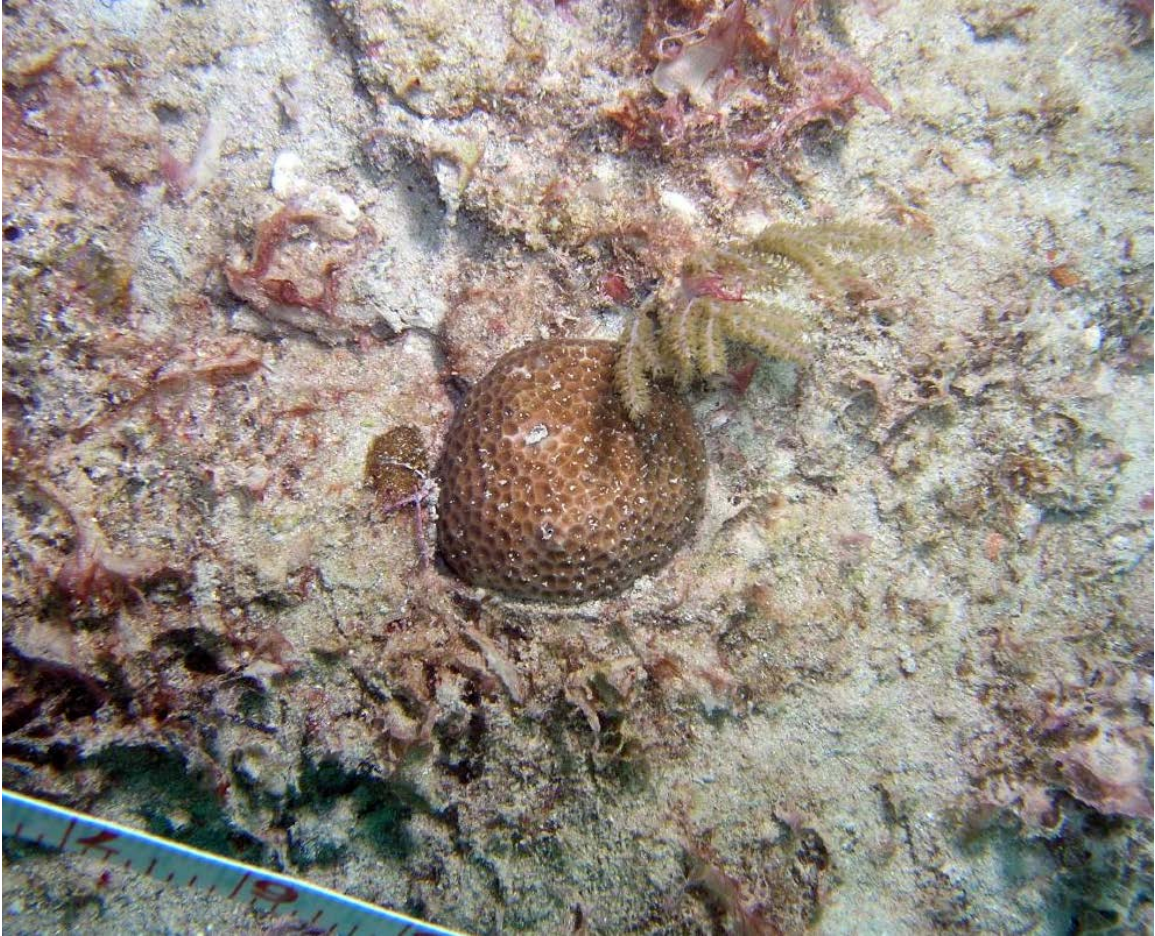
Figure 5. Small *Siderastrea siderea* at Control Site HBSC1 exhibit no sedimentation stress.

Sedimentation appeared to have no adverse effect on corals (Figures 5 and 6), octocorals, and sponges, except for the presence of the above-mentioned slight cover with fine sediments over substrate, which may have stimulated the development of cyanobacterial growth. The distance from this site to the channel (1400 m) is not necessarily long enough to completely discount the possibility that fine material can reach this area with the turbidity plume; see aerial photo in Fig. 7, where the length of the plume is over 1500 m to the west and 1000 m southwest from the source of turbidity.

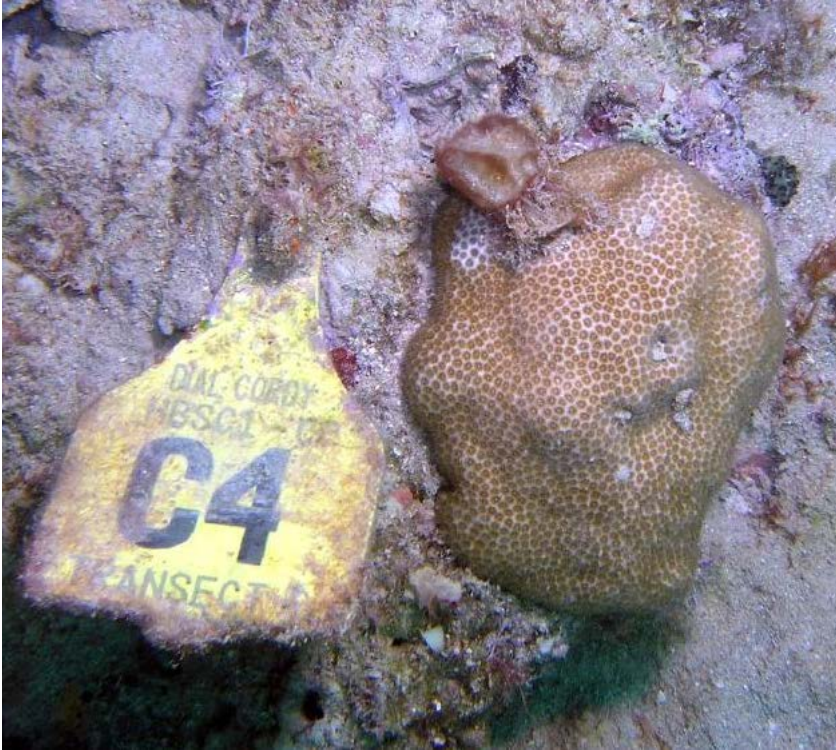
Figure 6. Small *Stephanocoenia intersepta* showing no sedimentation stress, although algae are smothering one side of the colony. Notice characteristically low sediment accumulation on the tag.

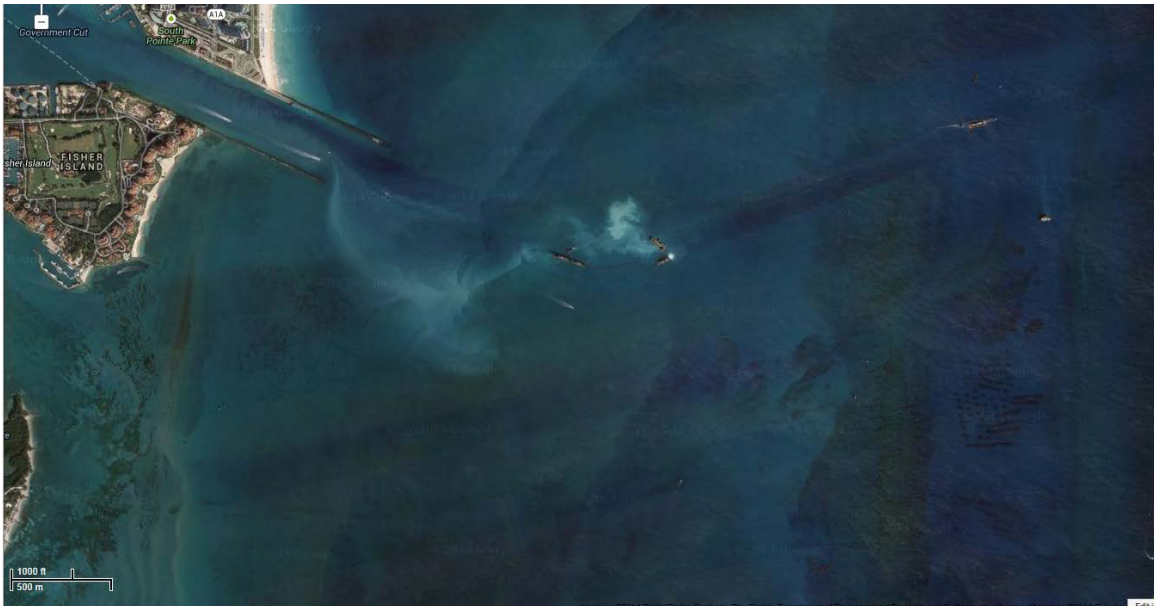
Figure 7. Aerial photo of current dredging (adopted from Google Maps in July of 2014). The length of turbidity plume is over 1500 m westward and 1000 m southwestward. There were no documented turbidity violations at this time according to project data.

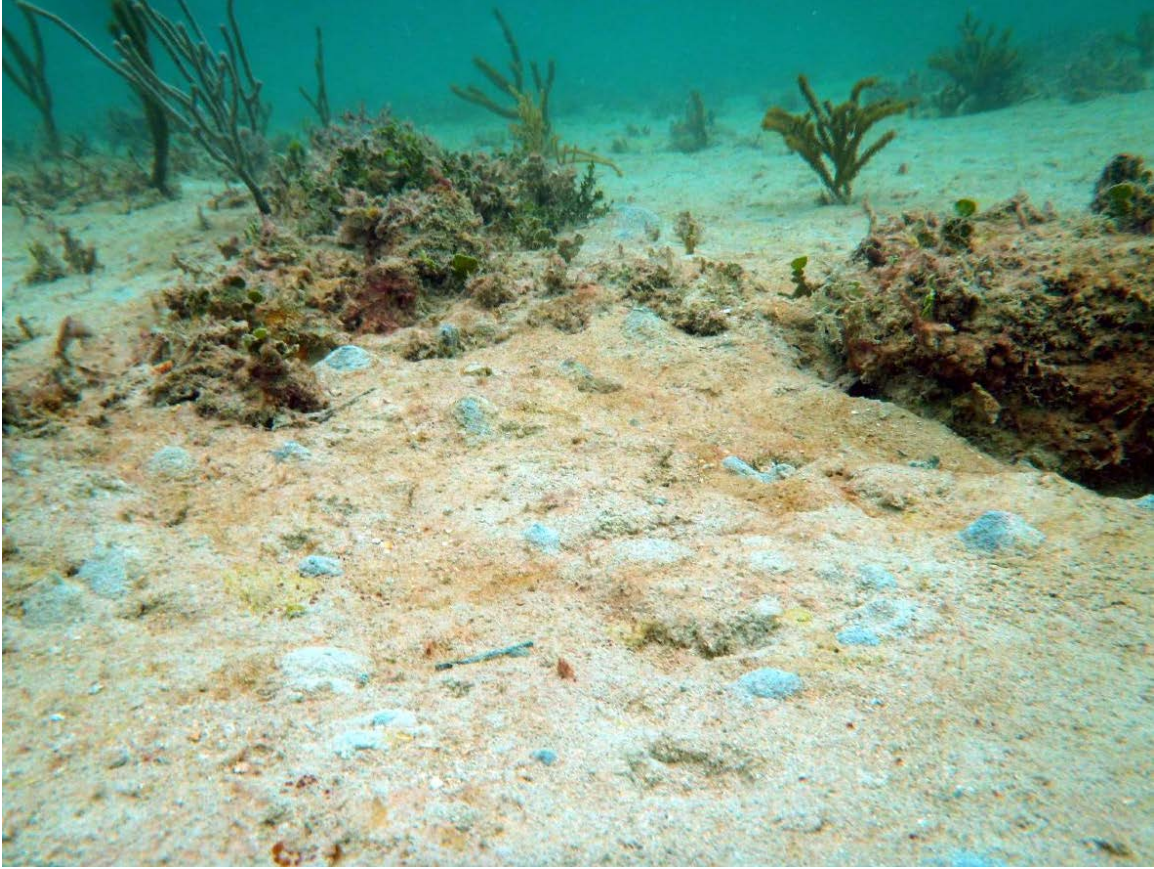
Figure 8. Landscape south of the site HBS4. A layer of fine sediments covers practically entire hardbottom. Holdfasts of octocorals are buried under 1-5 cm of sediments. Gray cones are borrows of benthic infauna; gray color is because the sediments are excavated from anoxic layer.

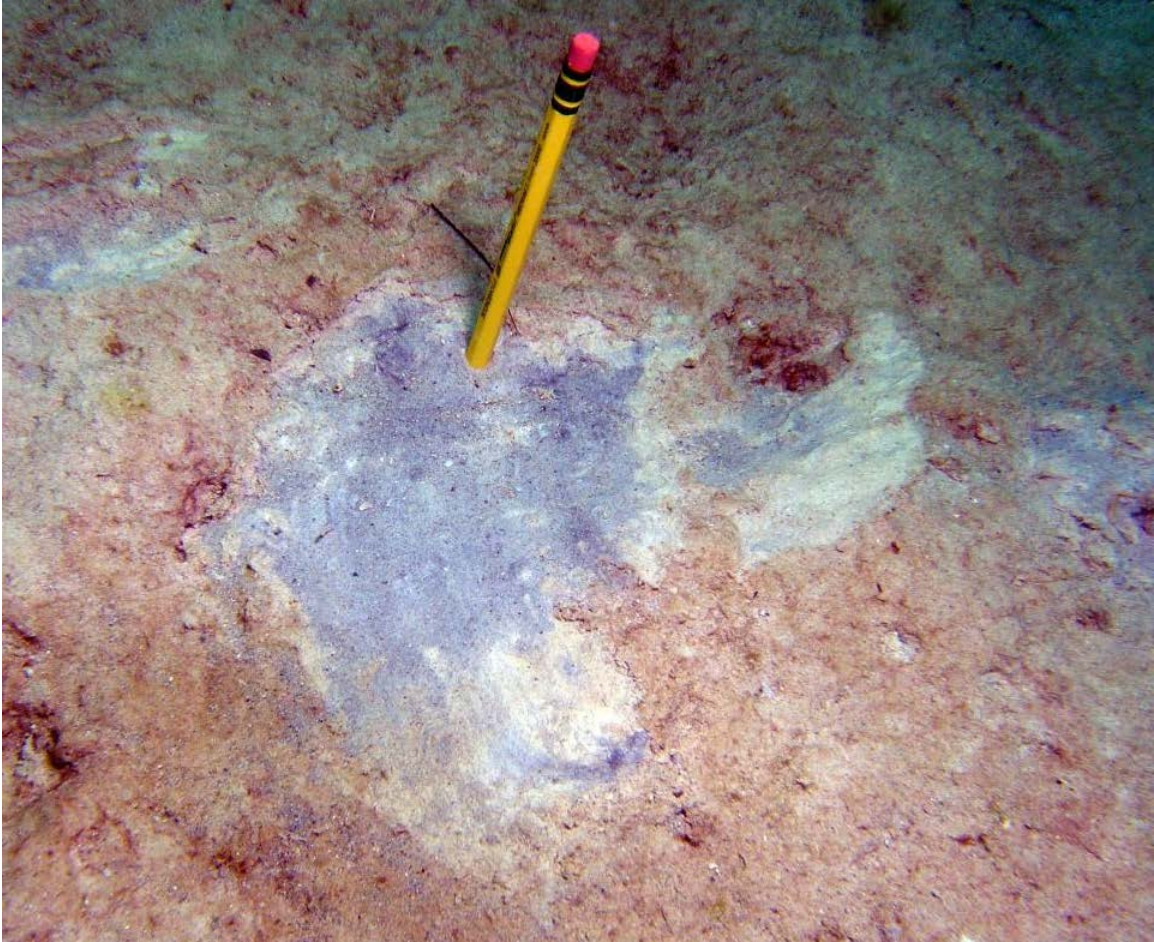
Figure 9. Sediments that covered practically entire area more than 100 m from the channel and southward from monitoring sites HBS3 and HBS4 become anoxic in less than 1 cm below the surface. Notice that almost all surface of recently accumulated fine sediments was covered with cyanobacterial mat.

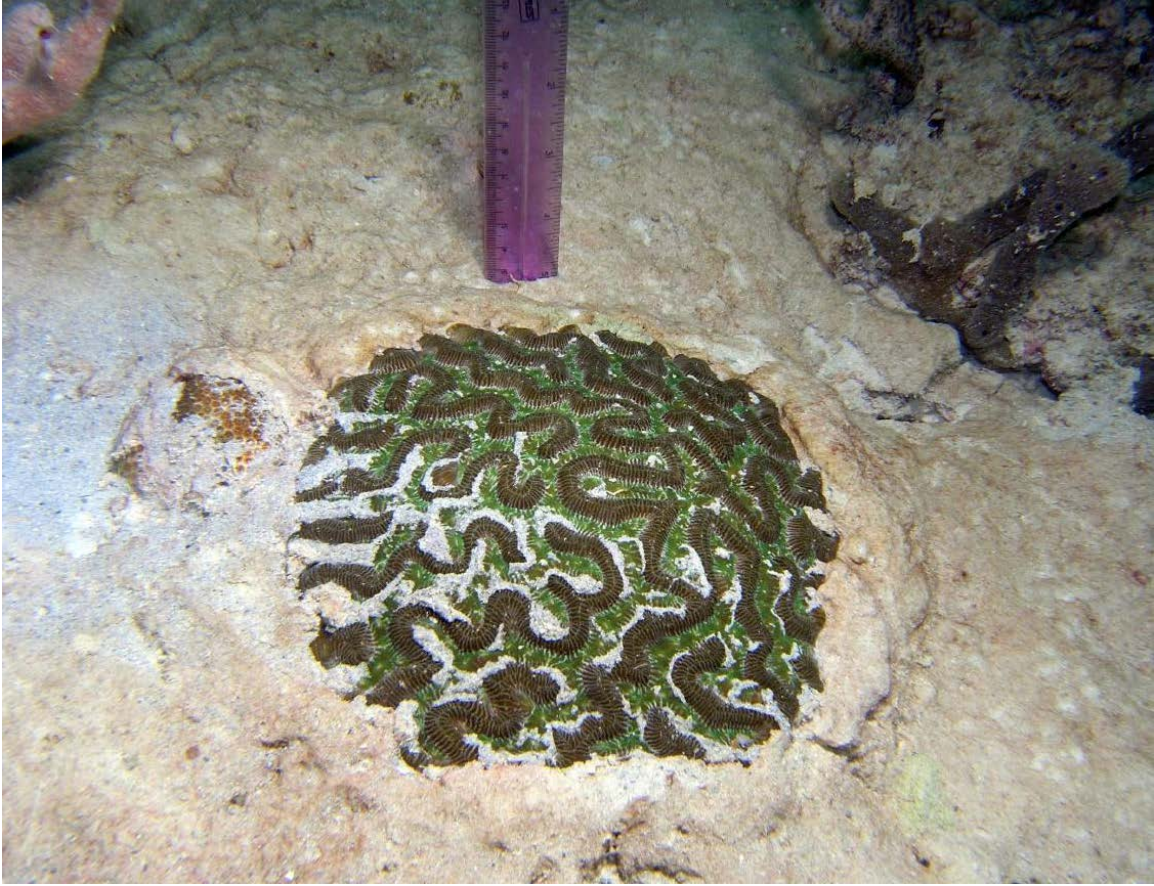
Figure 10. Sediment cover over *Colpophyllia natans* and *Stephanocoenia intersepta*. *Colpophyllia natans* was able to remove considerable amount of sediments from top of colony down to its base, forming thick rim of sediments at the base of coral, which buries lower part of the colony. See next picture in Figure 11.

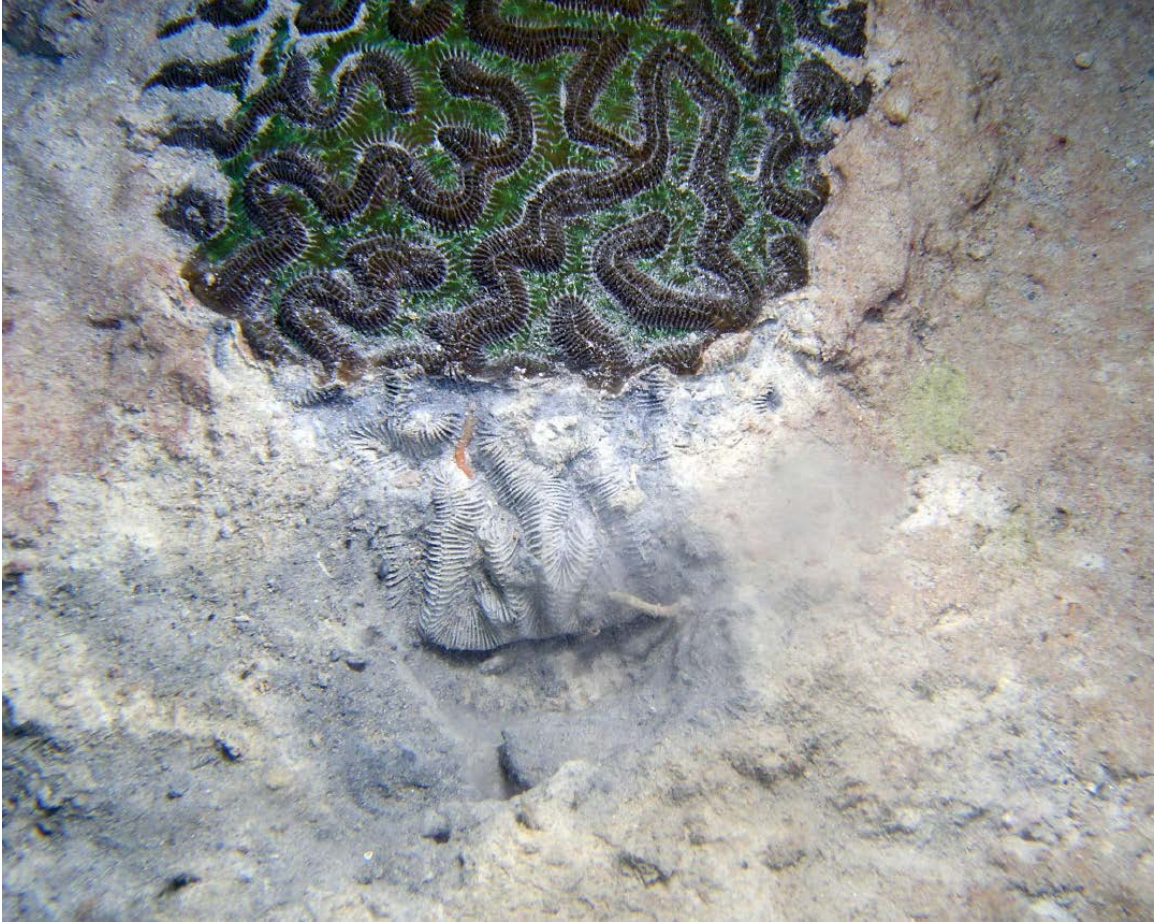
Figure 11. The same colony of *Colpophyllia natans* after sediments were removed from the base of the colony. Considerable part of the colony is dead due to the accumulation of sediments at its base.

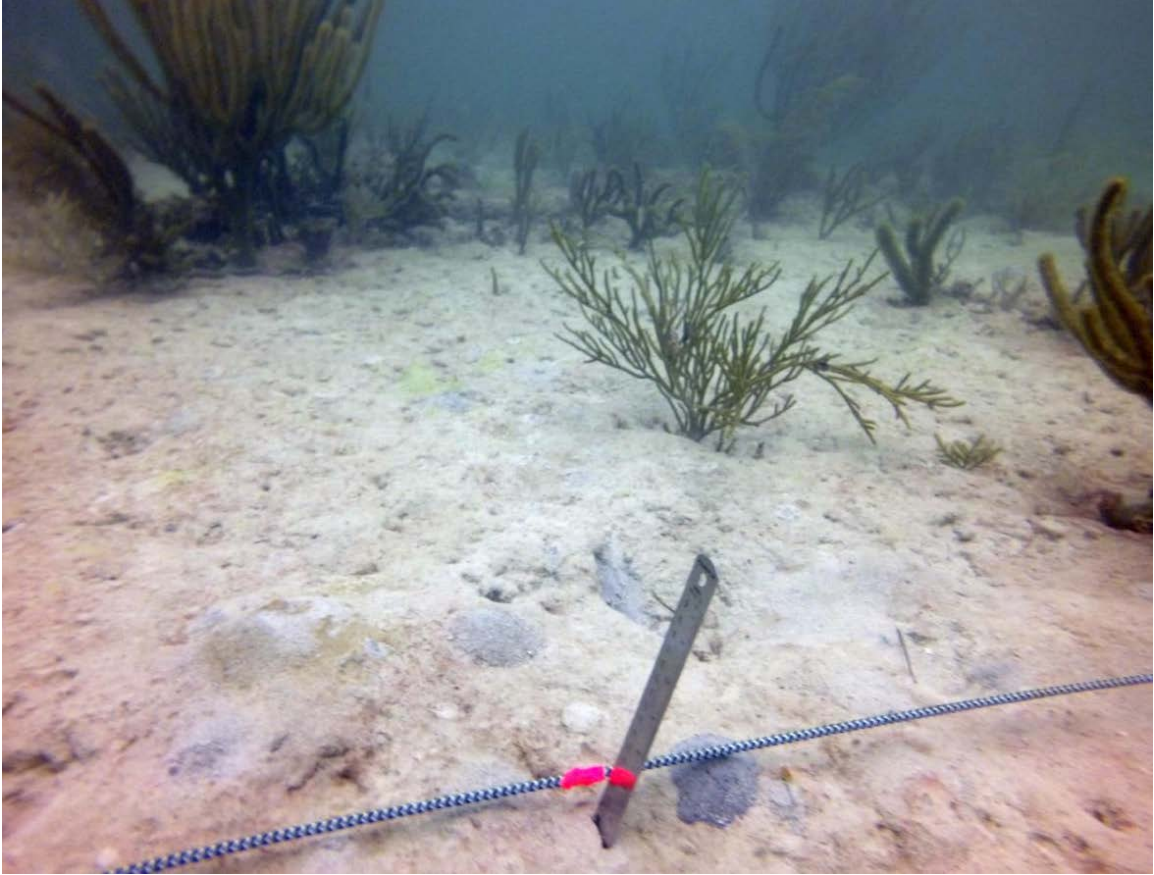
Figure 12. Landscape along the transect south of compliance station HBS3. Sediment accumulation was continuous along transect and was measured every meter.

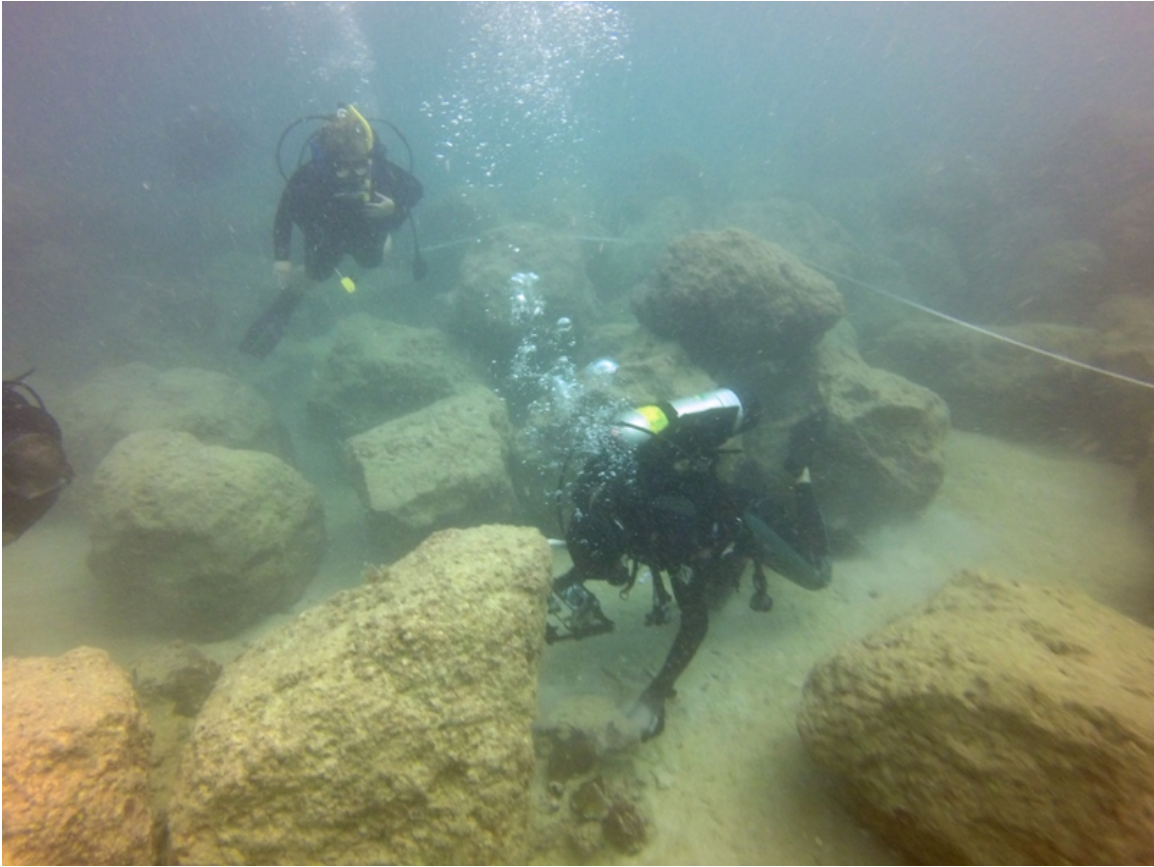
Figure 17. Diver is checking on hardbottom with boulder placed on it and broken large colony of *Montastraea cavernosa*.

- Damaged corals and octocorals should be transplanted as soon as possible to prevent mortality. The extent of the impacts to natural hardbottom in the area of mitigation reef should be surveyed, and the results of this survey should be provided to the Department. The results of this survey shall be evaluated by the Department to determine if additional mitigation is necessary. Department staff are available to provide assistance in the preparation of monitoring and transplantation protocols.

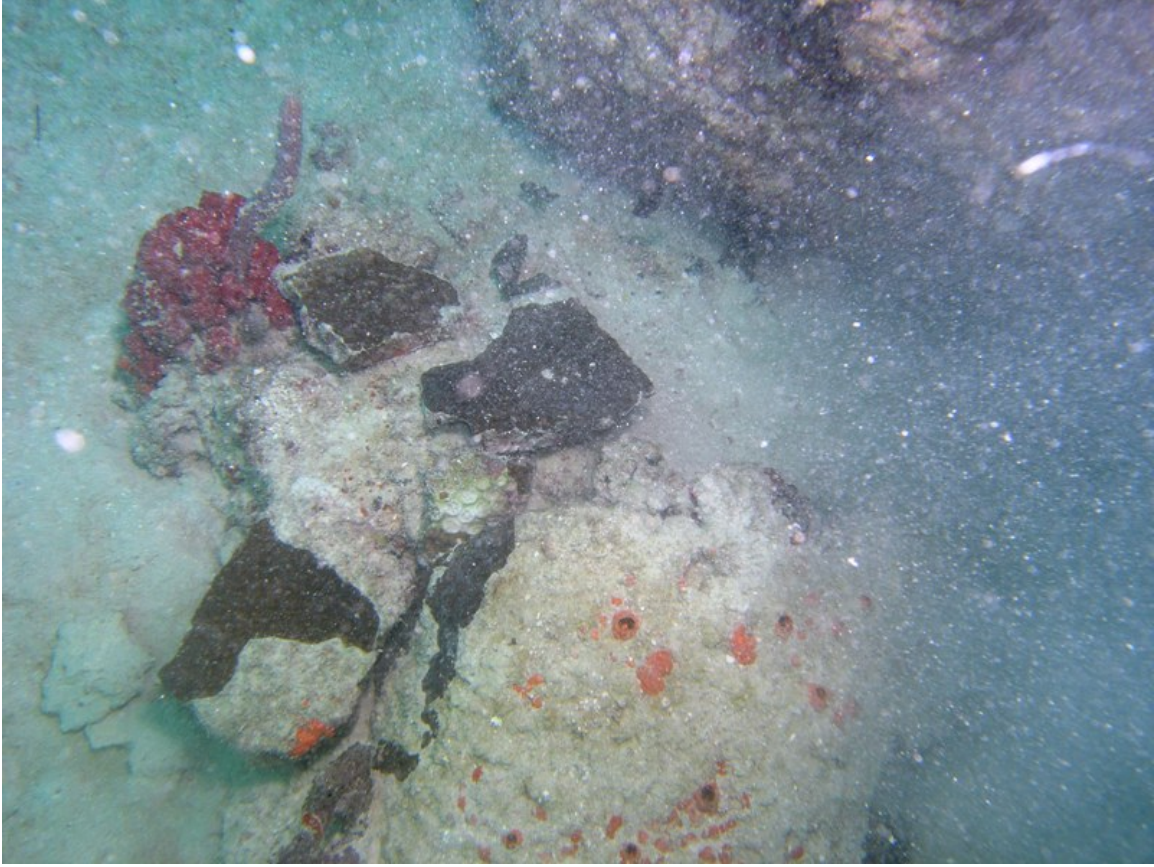
Figure 18. Fragments of broken *Montastraea cavernosa* in the area of artificial reef. Coral was broken during the construction of artificial reef by boulder dropped on natural hardbottom.

During the Department’s site inspection, impacts were also documented at the mitigation reef site. Boulder placement at the site had damaged natural hardbottom resources and violated specific condition 33. A fast response to this issue may minimize long-lasting impacts.

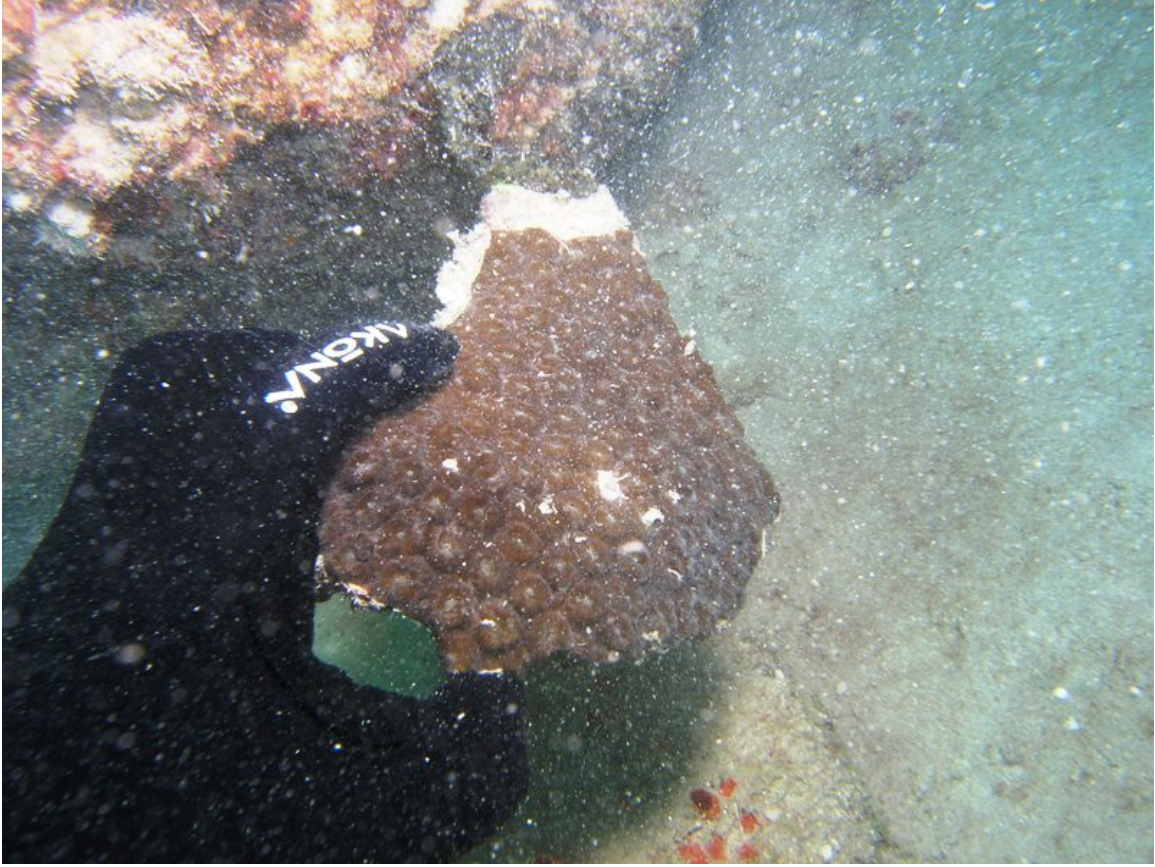
Figure 19. A fragment of broken colony of *Montastraea cavernosa*.

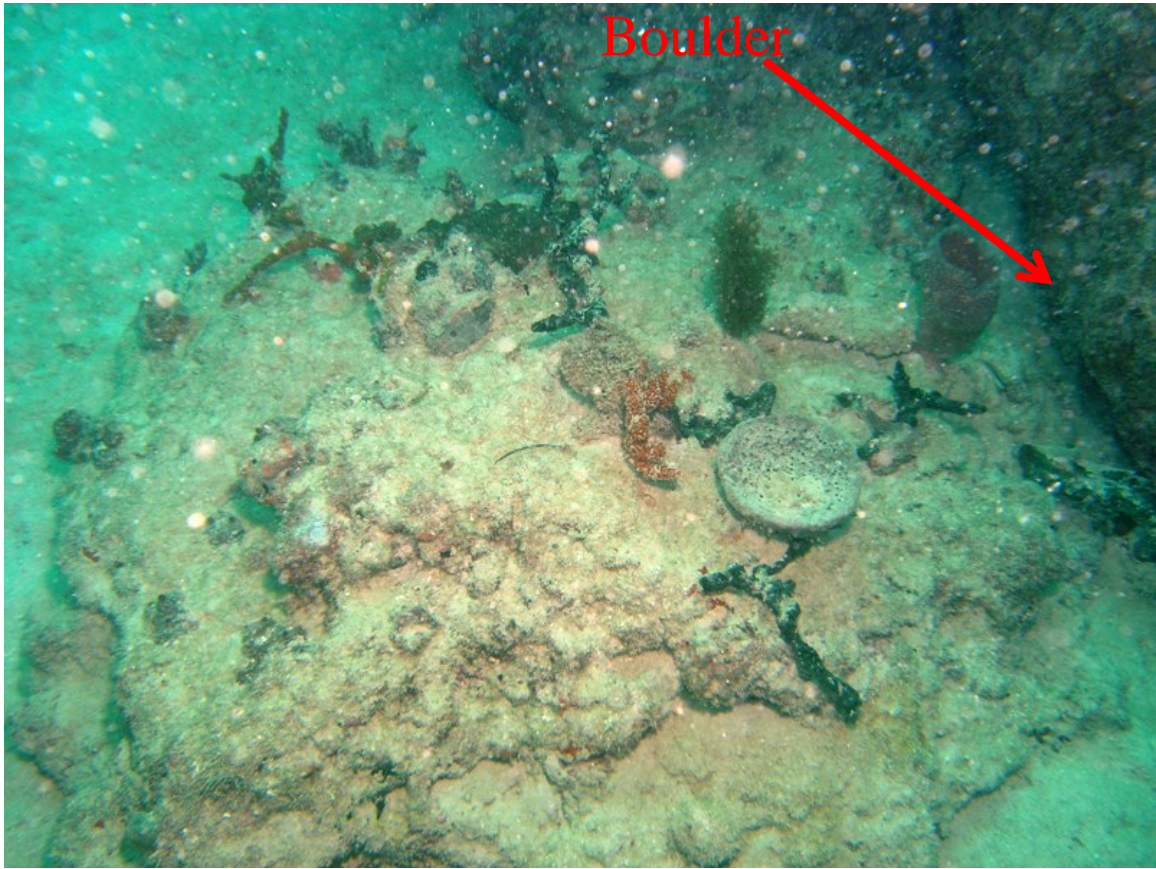
Figure 20. Patch of hardbottom with boulder placed over it.

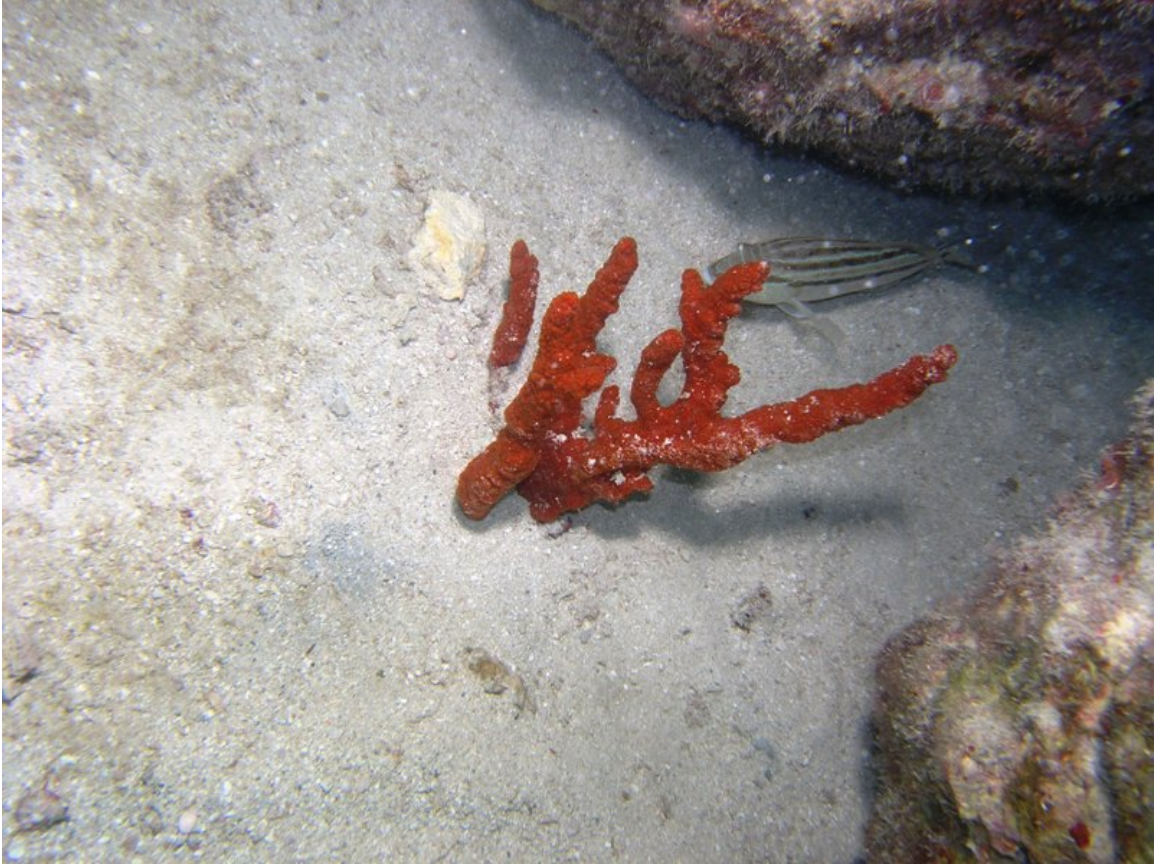
Figure 22. Sponge *Ptilocaulis walpersii* is partially buried by sediments displaced by adjacent boulder.

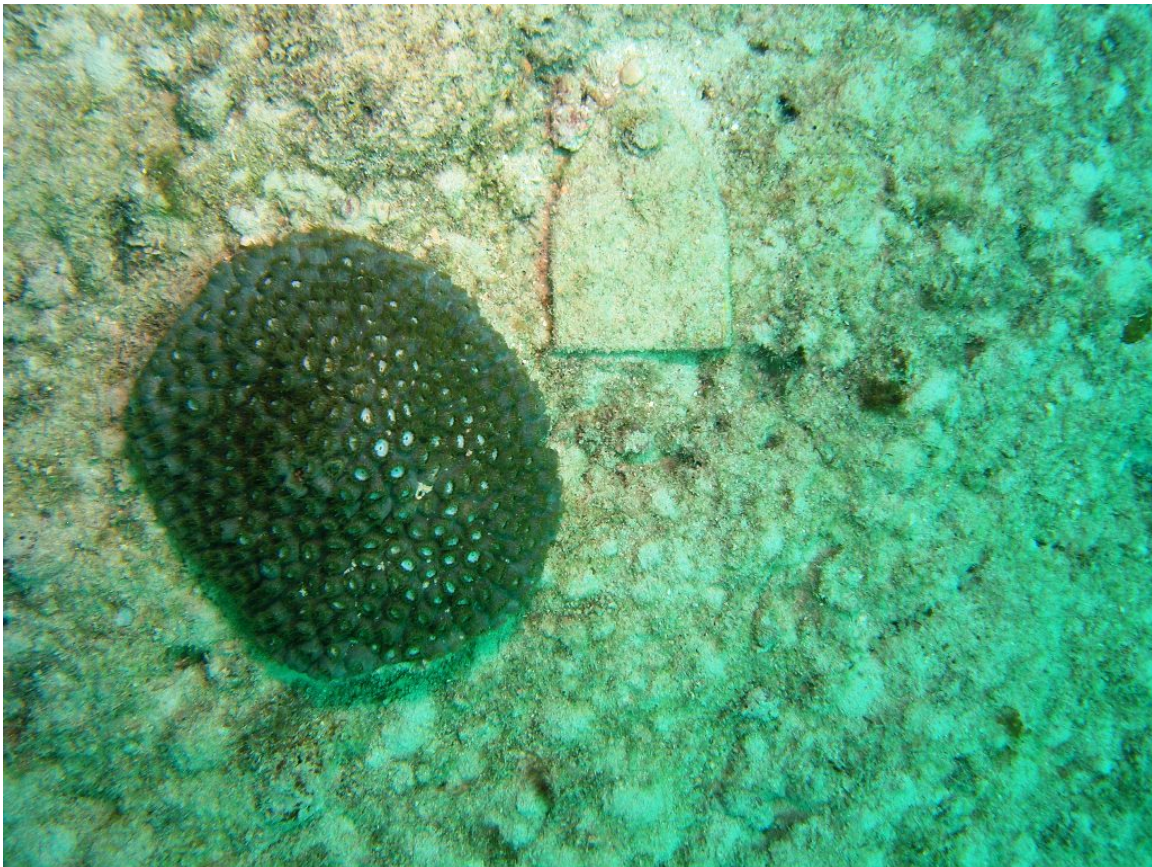
Figure 23. Small *Montastraea cavernosa* at the transplantation site on leeward (shoreward) side of the Outer Reef. Surrounding hardbottom is covered with sediments (note also that coral tag is completely covered with sediments, although tags are regularly cleaned during monitoring events), although sediments seems to have minimal effect on the coral.

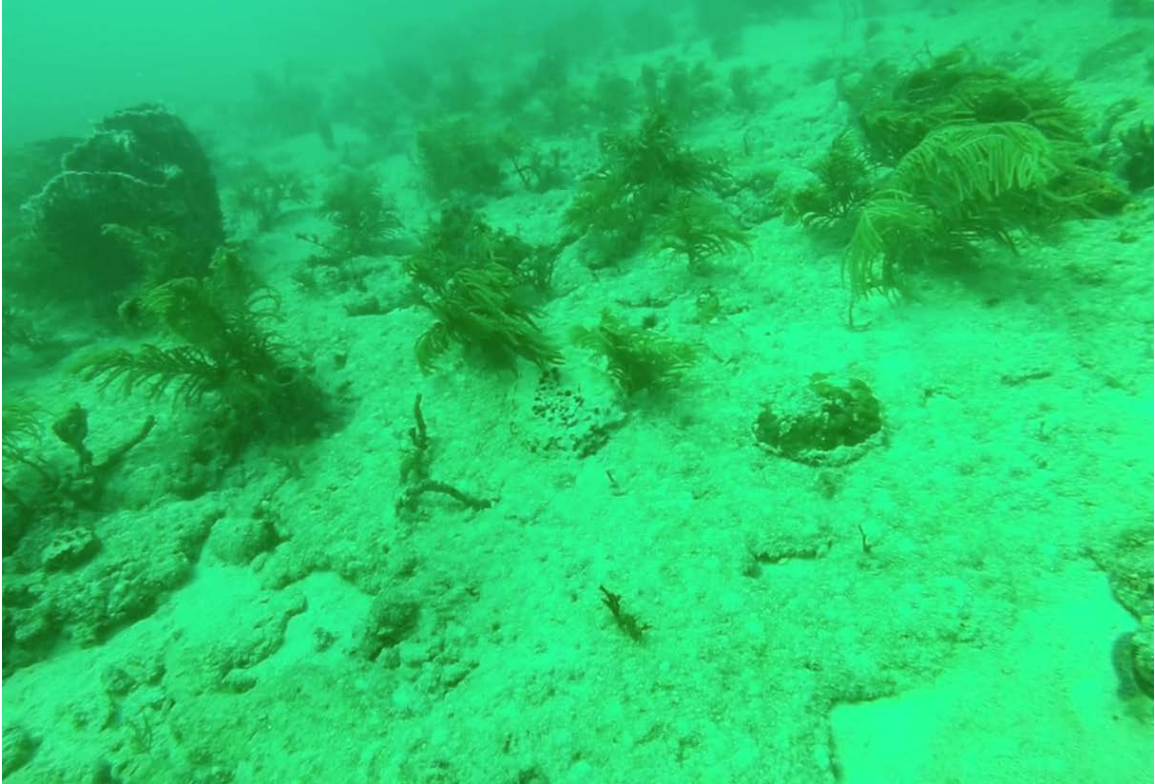
Figure 24. Landscape north of the transplantation site on leeward (shoreward) side of Outer Reef. Hardbottom and sand patches covered with thin layer of fine sediments.

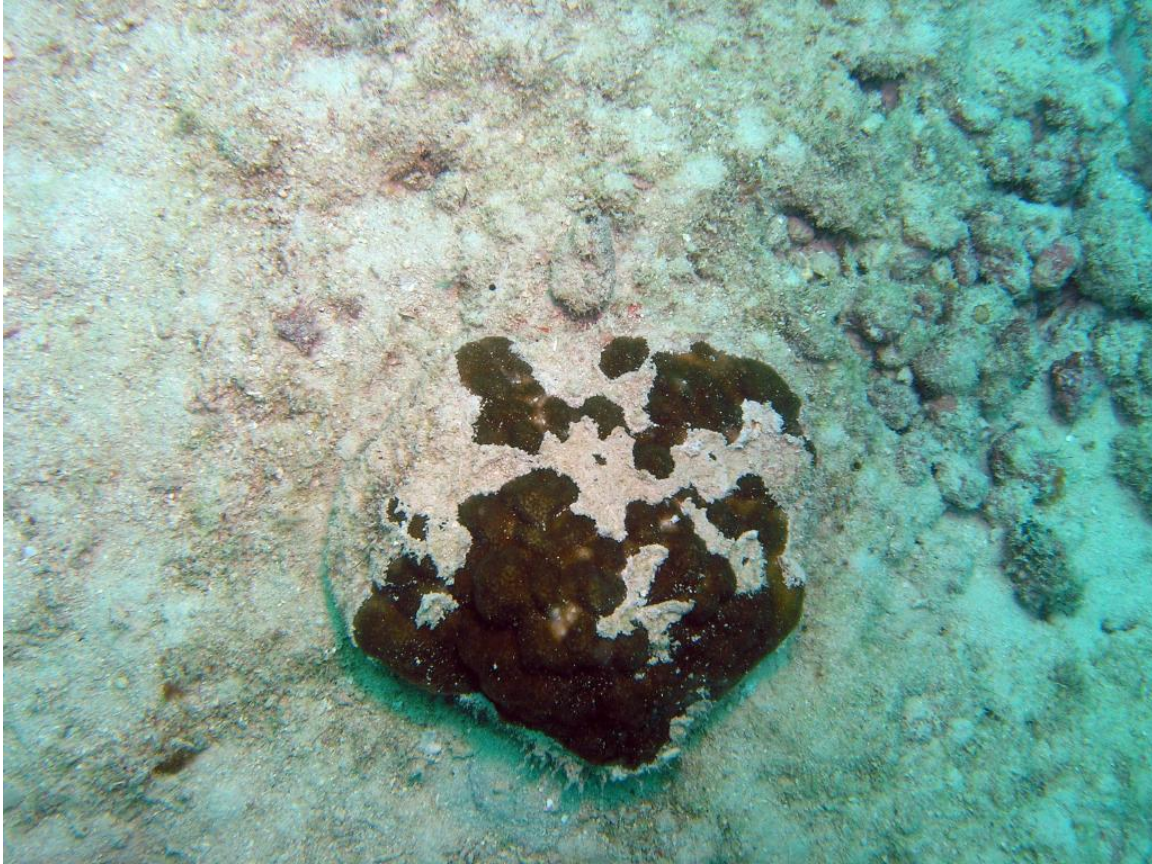
Figure 25. Colony of *Porites astreoides* was affected by accumulation of fine sediments, which caused about 50% mortality of the colony.

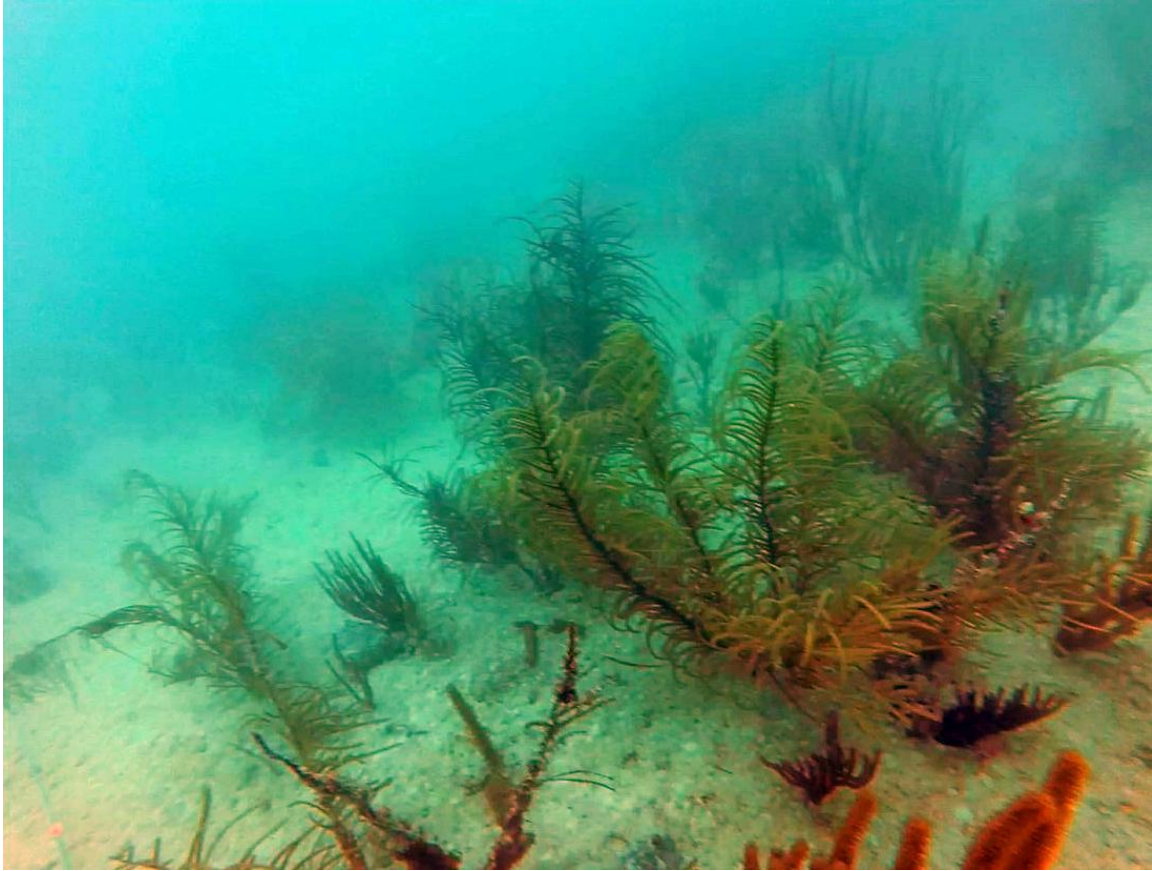
Figure 26. Landscape along 200 m transect north of compliance site R2N1.

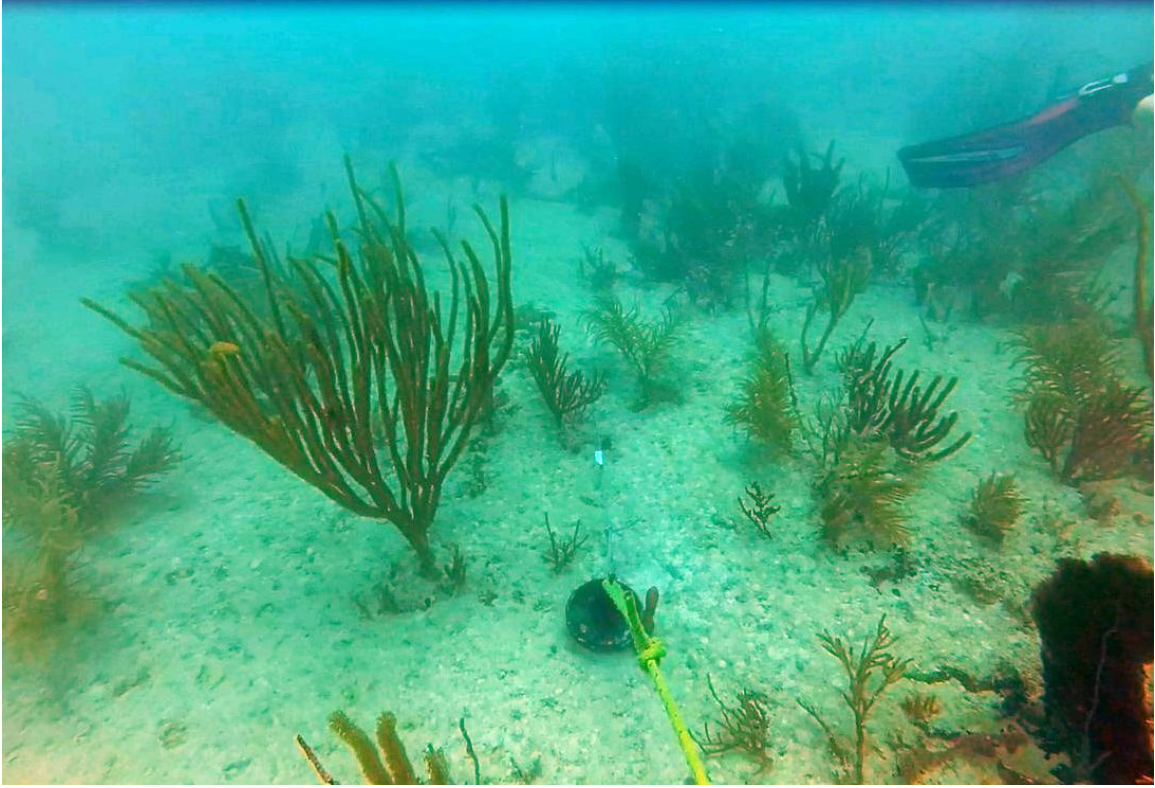
Figure 27. Landscape at the end of 200 m long transect north of compliance site R2N1.

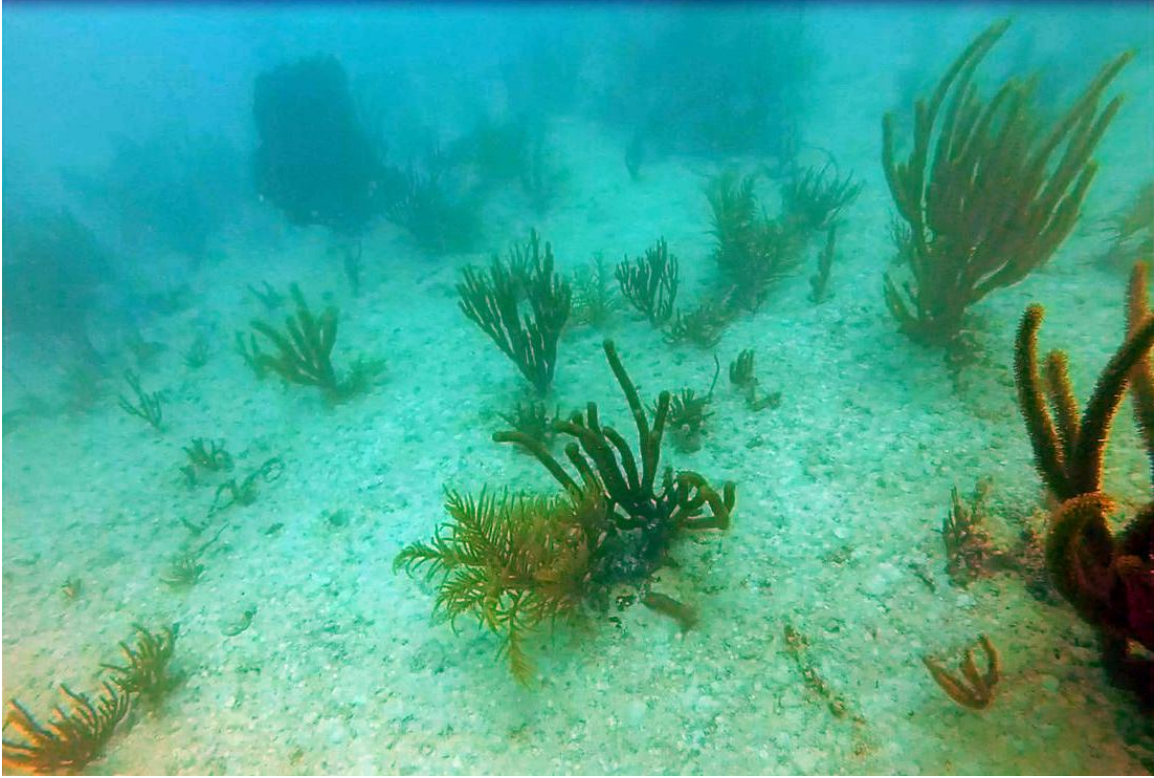
Figure 28. Landscape along 200 m transect north of compliance site R2N1. Note continuous cover of hardbottom by sediments (in this picture, two landscape pictures above and one below).
