RE: WARNING LETTER OF POSSIBLE VIOLATIONS AND NON-COMPLIANCE

**Miami Harbor Phase III Federal Channel Expansion
Permit No. 0305721-001-BI
County: Miami-Dade**

**Field notes on impact assessment in Miami Harbor Phase III Federal Channel
Expansion Permit # 0305721-001-BI**

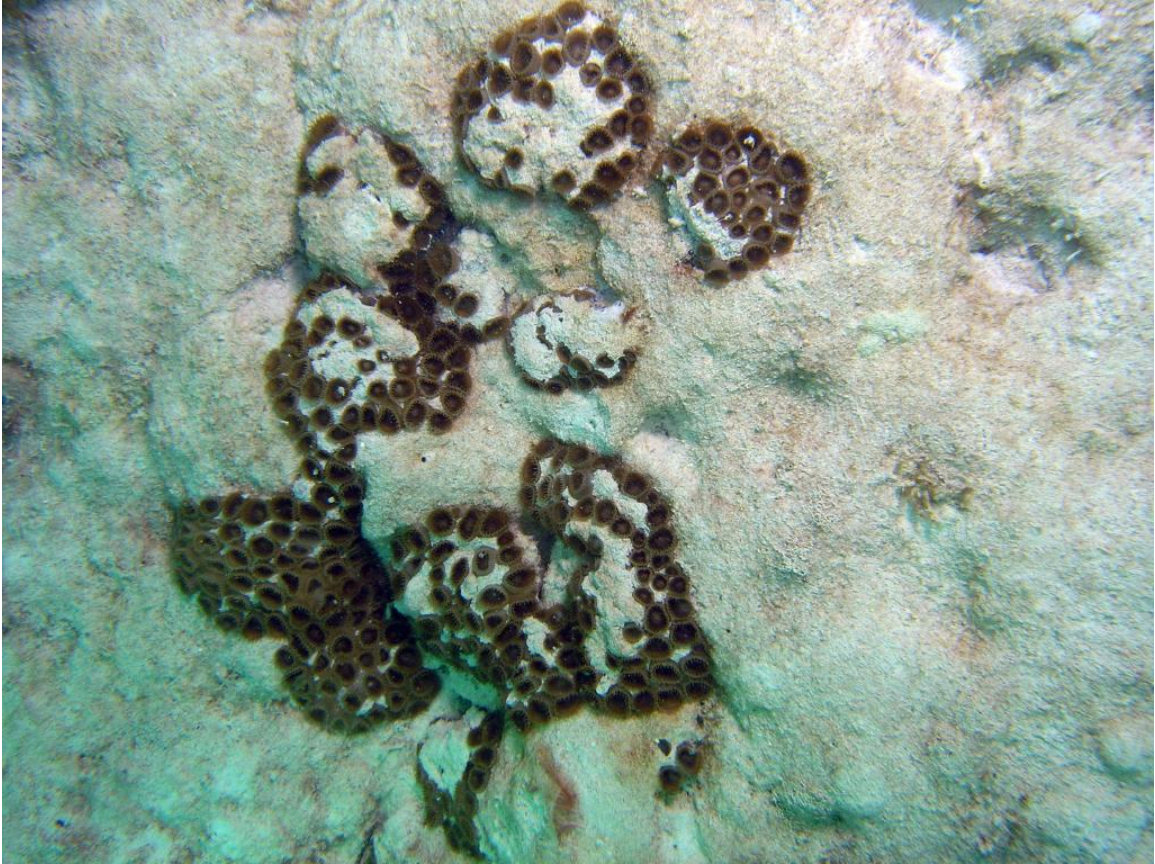
Figure 29. *Palythoa caribaeorum*, which is normally quite tolerant to sedimentation, is in dire condition due to cover by layer of fine sediments.

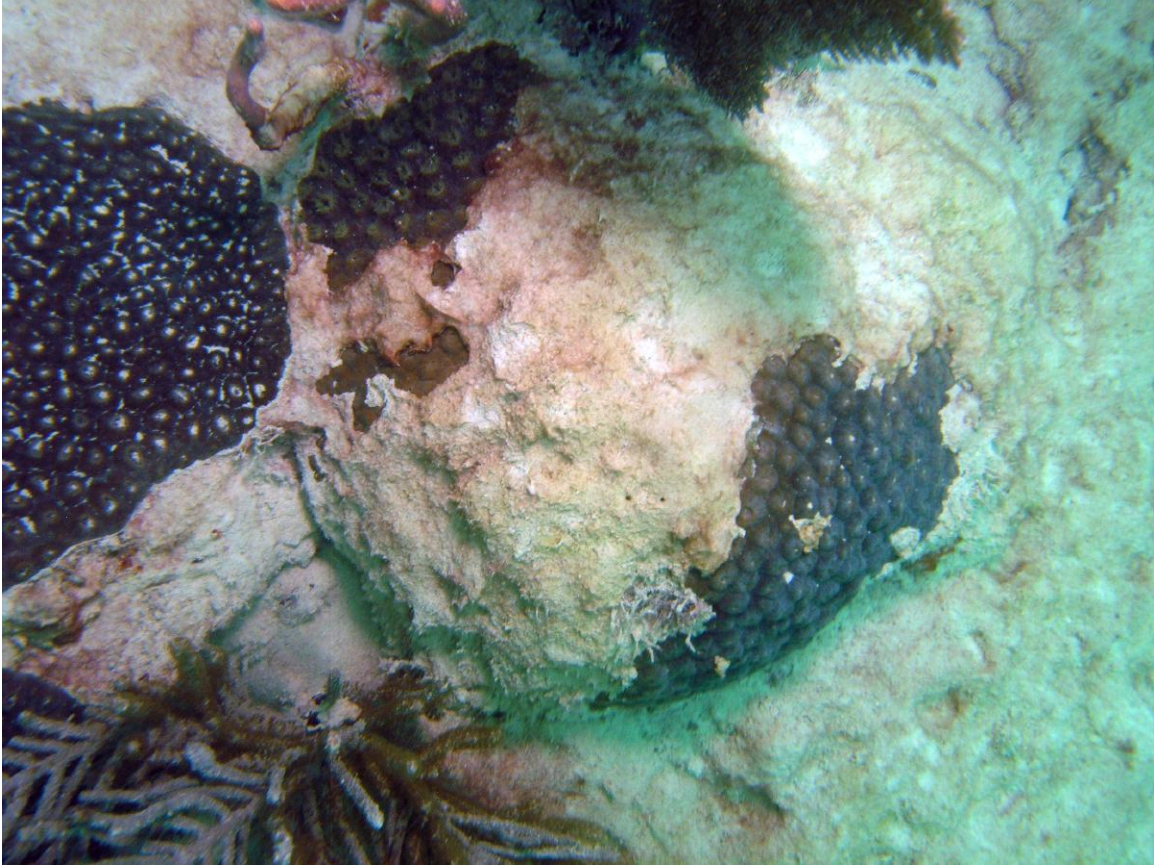
Figure 30. *Montastraea cavernosa* has over 50% of mortality due to sediment accumulation.

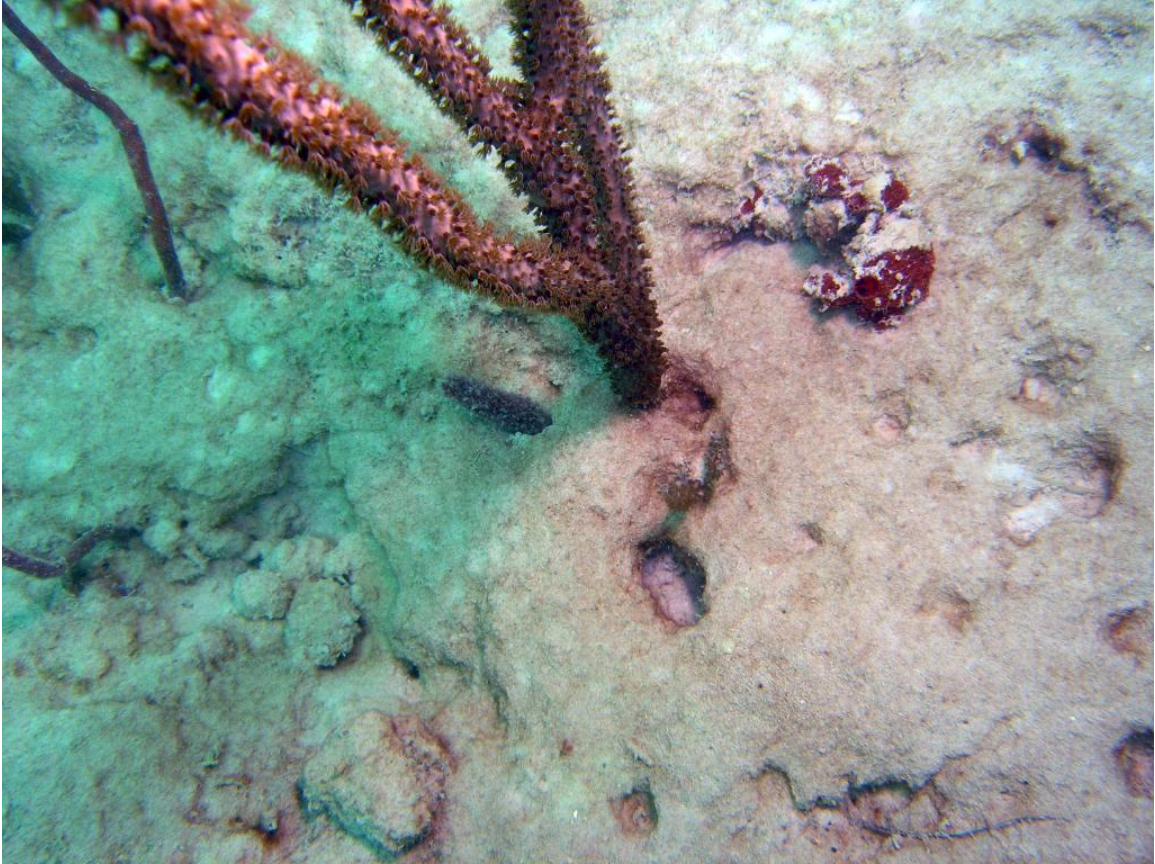
Figure 31. The holdfast of octocoral is buried; a small sponge nearby has been buried too. North of site R2N1.

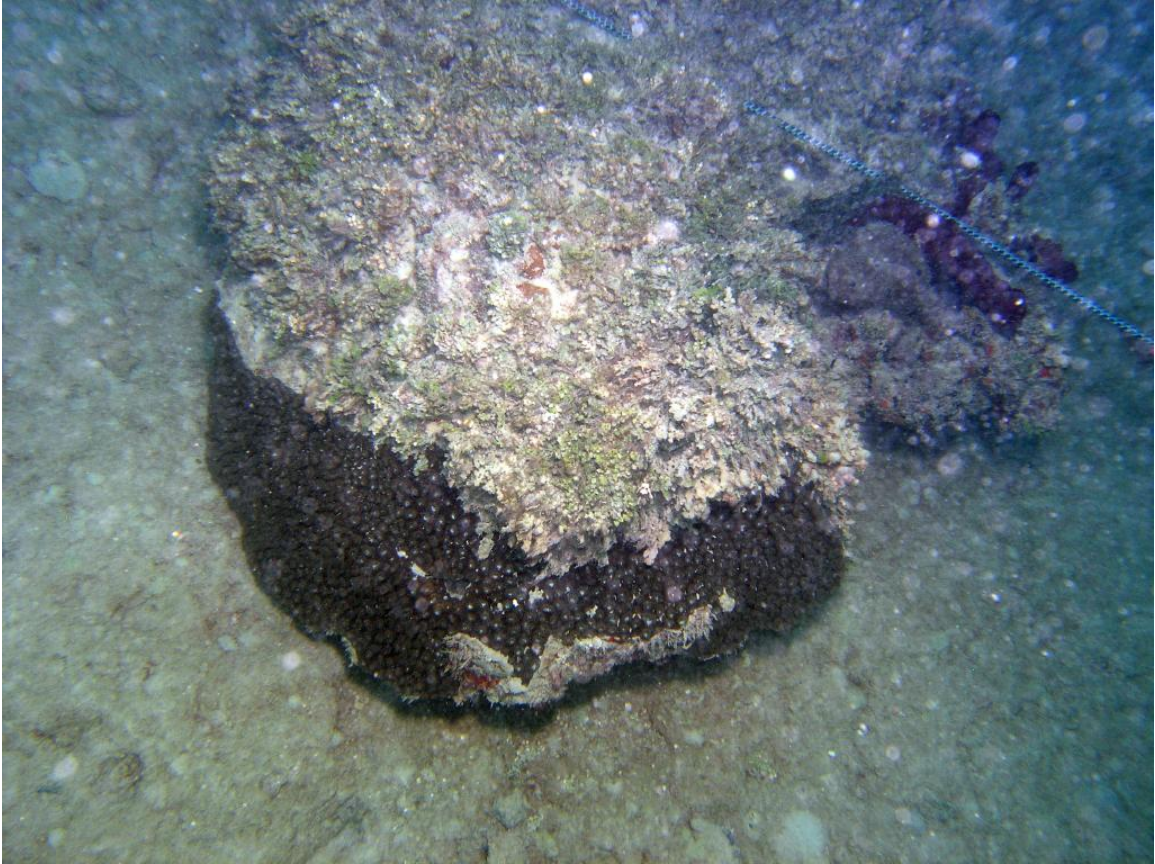
Figure 32. Small knoll formed by *Montastraea cavernosa*; the top of colony is dead and overgrown by *Halimeda* sp.

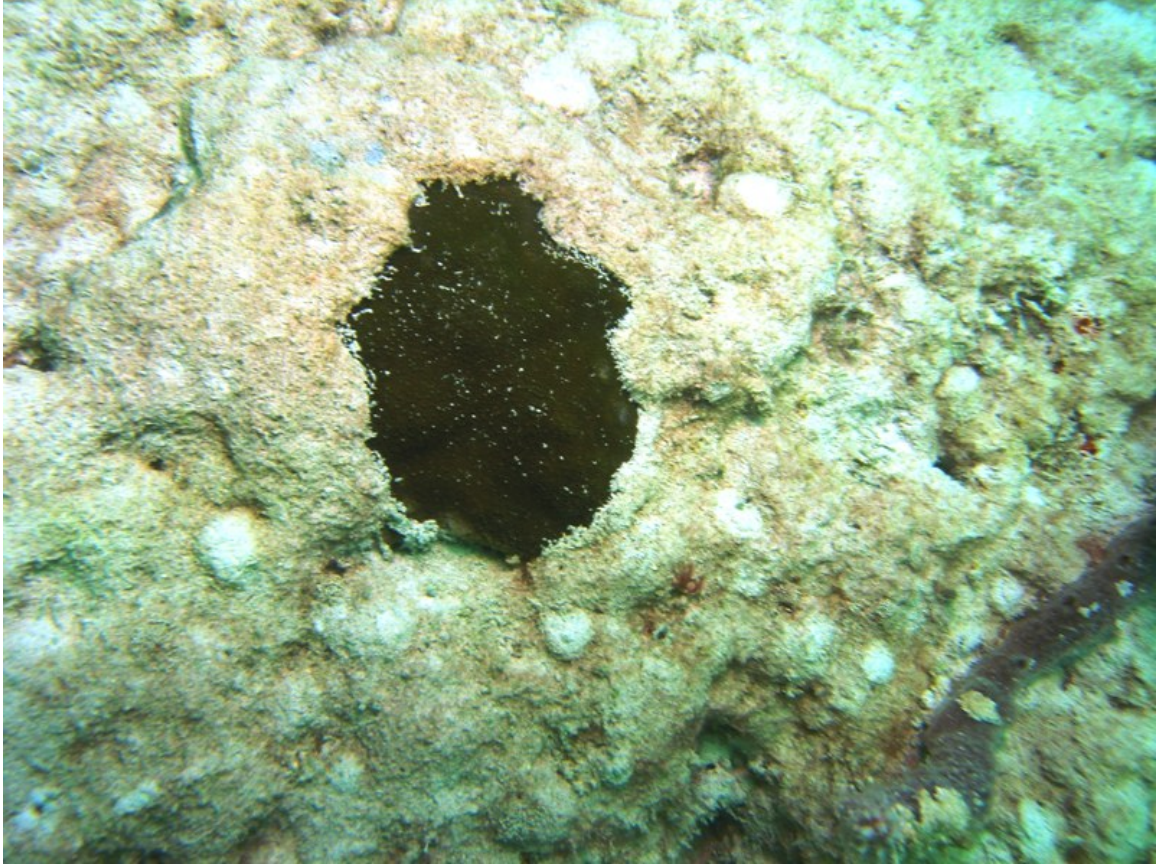
Figure 33. *Porites astreoides* colony experienced considerable burial and partial mortality (see also next picture).

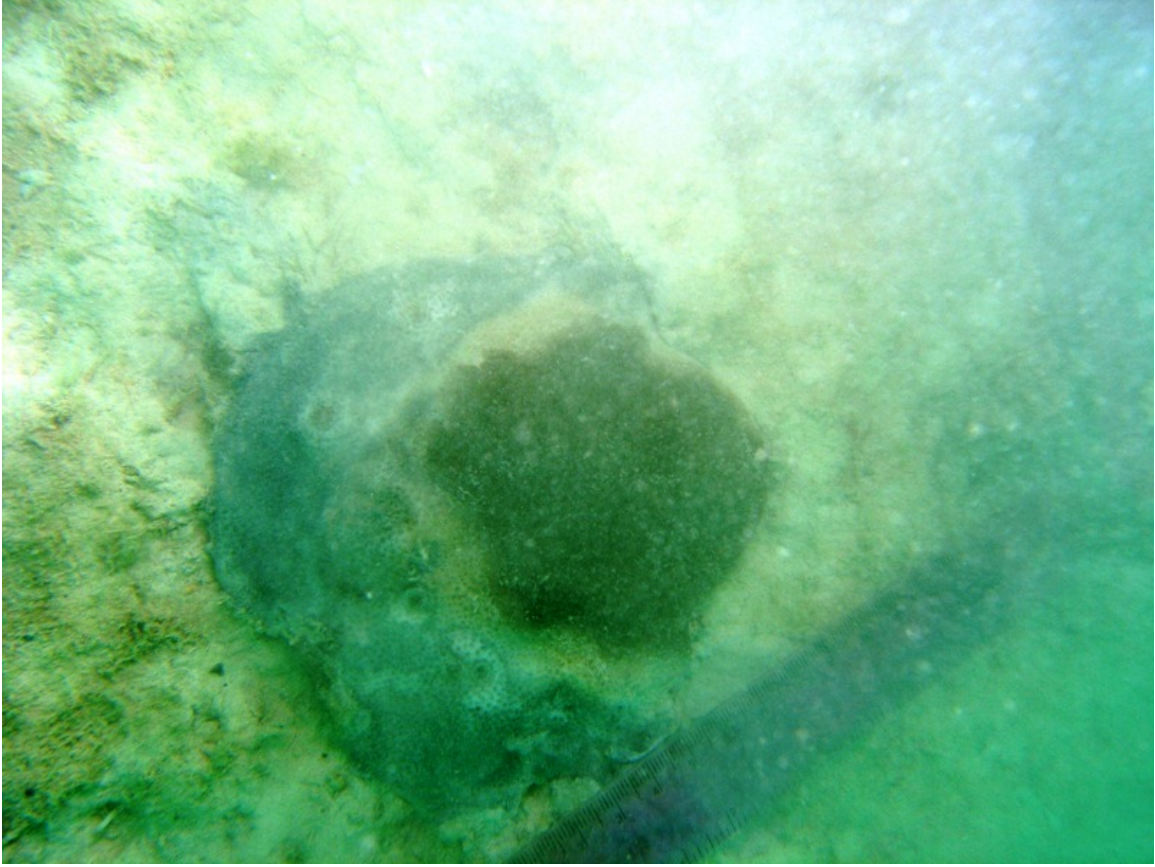
Figure 34. The same colony of *Porites astreoides* as in previous picture after excavation from sediments. 60% to 70% of colony is dead.
